Upgrade Procedure for Version 1.21

1. SCOPE (uSD Card Issues)

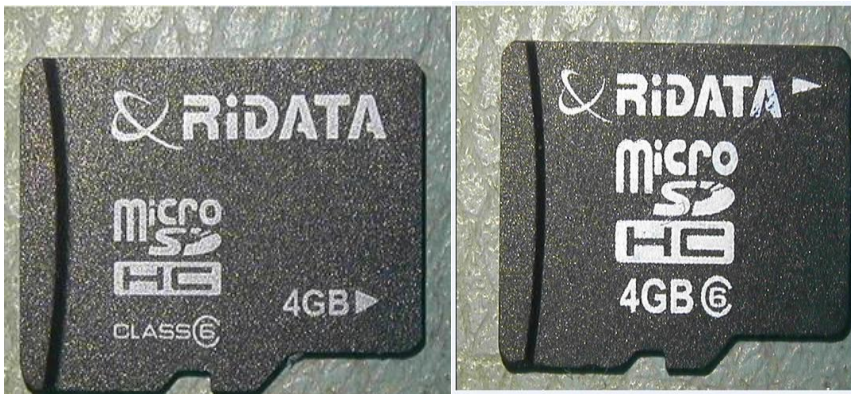
Figure 1 μ SD Card pictures

Each customer will have to verify the μ SD card in their cameras. If the μ SD card is identical to one of the pictures shown in Figure 1, customers should switch it from the internal slot to the external slot **prior** to performing any firmware upgrade.

Instruct customers to perform this procedure on HD77 cameras **prior to upgrading the cameras to latest FW version.**
