Upgrade Procedure for Version 1.21

1. SCOPE (uSD Card Issues)

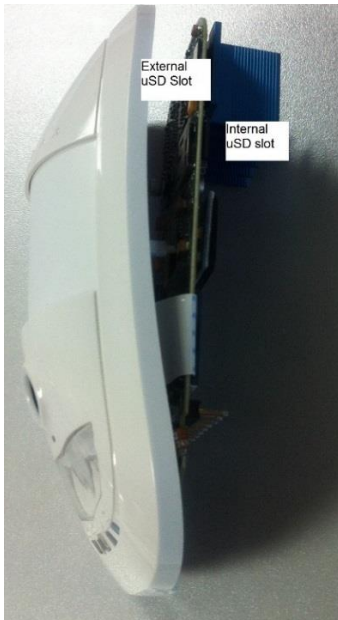
Figure 2 HD77 Camera External vs Internal slot

Each customer will have to verify the μ SD card in their cameras. If the μ SD card is identical to one of the pictures shown in Figure 1, customers should switch it from the internal slot to the external slot **prior** to performing any firmware upgrade.

Instruct customers to perform this procedure on HD77 cameras **prior to upgrading the cameras to latest FW version.**
